OBSERVATION OF THE NEARSHORE WATER CIRCULATION OFF A SAND BEACH

Submitted in partial fulfillment of the requirements for the degree of

United States Naval Postgraduate School Monterey, California

1964

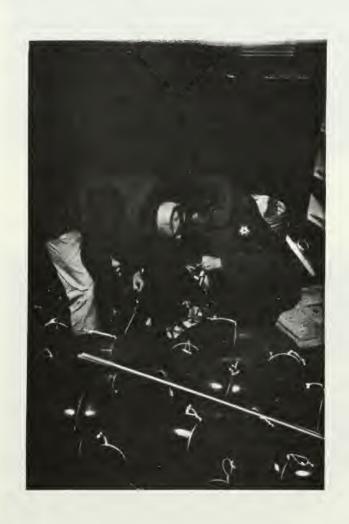
Figure 4. Double Innertube Floats.

The float that was selected for the surveys was devised by the writers and is illustrated in Fig. 4. It consisted of two automobile innertubes lashed together, the lower one being water-filled and the upper one air-filled and painted to enable good visibility from the air. Dye-marker packets were attached to each float for added visibility. A 40-foot motor launch owned by the USNPGS was used to test the various floats, but it was not used in the surveys that followed because of the hazard of its getting caught in a breaker while launching or retrieving floats a short distance seaward of the surf zone.

- 2. Disadvantages: The single tube was difficult to see in aerial photographs due to its floating flush with the water surface.
- B. Double tubes: Two innertubes were lashed together, one on top of the other, with the top tube filled with air and painted for visibility and the bottom one filled with fresh water (Fig. 4). Dye-marker packets were attached to each double innertube float. The floats were observed to leave a well-defined trail of dye which not only gave an excellent means of locating the float in an aerial photograph, but also gave an indication of the track of the float with respect to the surface water motion.

Double innertube floats were selected for use in this study because of their durability and their visibility from the air, both in the surf zone and to seaward of it. Although balloons were not used, they are believed to have good potential as a float for tracing surface currents in open water seaward of the surf zone and further experimentation is recommended.

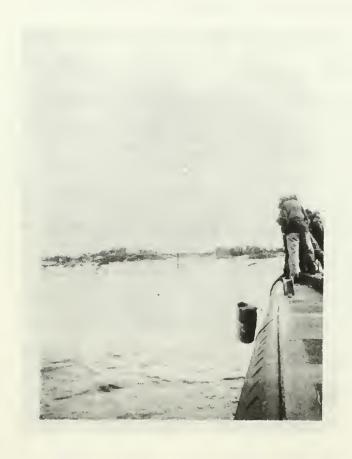
Figure 23. Launching of a Weather Balloon Float.

III. Weather balloons: A weather balloon filled with water was found effectively to form a unit of water which responds exactly to surface water motions while offering no sail area to the wind. Fluorescent dye was placed inside each balloon prior to filling to indicate leaks or position if the balloon was destroyed. The balloons proved very difficult to handle when full. The best system devised for filling and launching the balloons was to fill each in a 35-gallon trash can lined with kraft paper to avoid puncturing on the rough surfaces of the can, and to throw the can and balloon over the side (Fig. 23). The bottom of the can took the brunt of the impact and was retrieved by an attached line after the balloon floated free. When brightly painted the balloons were readily visible from the air. Prior to filling with water they were inflated with air and spraypainted various colors, although the results were inconclusive as to which color was best. The colors used were red, orange, yellow, metallic copper, metallic brass, metallic silver, metallic gold, and fluorescent red. Standard 300-gram weather balloons were used in these experiments and were filled with both fresh water and salt water.
